**U.S. Army Corps of Engineers
Memphis District**

Mississippi River and Tributaries System

2011 Post-Flood Report

*Documenting the 2011 Flood,
the Corps' response, and the
performance of the MR&T System*

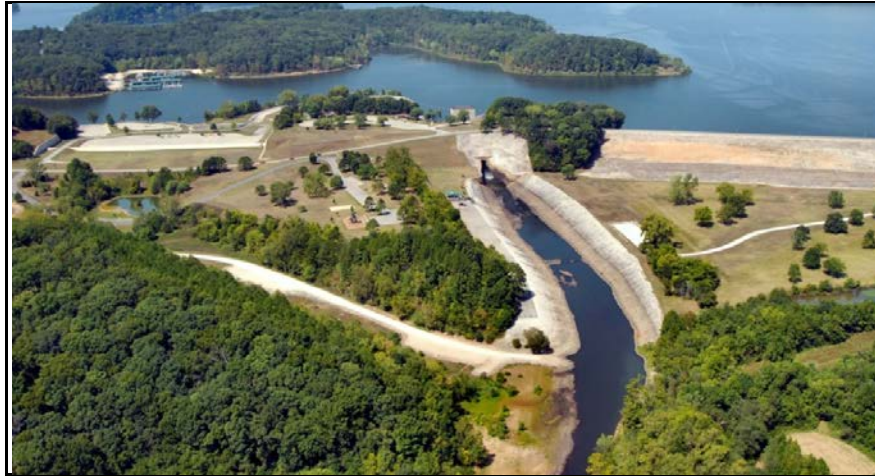
Photograph IV-1. Prior to 2011 Overtopping of Spillway

As a result of a second record rainfall, multiple peak inflows of greater than 100,000 cfs raised Wappapello Lake to a record pool level of 400.04 NGVD on May 3, 0.95 ft above the previous record and 5.30 ft above the auxiliary spillway. The berm which had been constructed across the auxiliary spillway was overtopped (photographs IV-1 and IV-2). Spillway overtopping resulted in significant damages downstream. By June 1, the pool level was down to 377.2 ft and 42 percent of the flood control storage utilized. By July 1, the pool level was successfully approaching rule curve level of 359.74 ft.

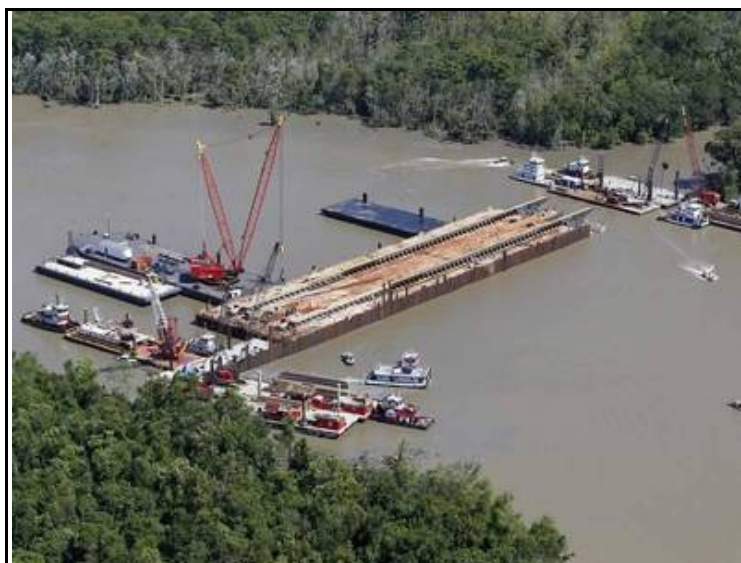
Photograph IV-12. Bayou Chene Closure

Due to the imminent threat of the Flood causing backwater flooding in the Atchafalaya River, on 6 May 2011, St. Mary Parish Levee District (SMLD) submitted a closure plan for Bayou Chene to both the Corps and the Louisiana Office of Coastal Management. On 9 May 2011, an emergency permit was granted, and SMLD began procuring equipment and material for the closure. Construction began on 11 May 11 (photograph IV-12).

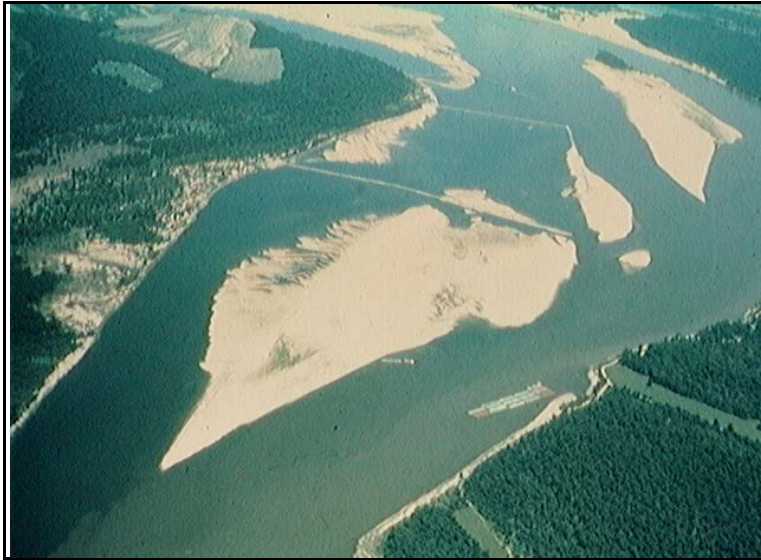
Photograph IV-13. Typical Dike

Dikes. Dikes are composed primarily of rock placed in the channel and extending into the bank with the crest significantly below top bank to have no effect on highwater stages, but high enough to concentrate relatively low flows in a specified width to provide a self-maintaining channel for navigation. Some dikes are constructed in a “W” configuration with a varying crest elevation to provide some diversity of flow conditions in the vicinity. Photograph IV-13 shows a typical dike field.

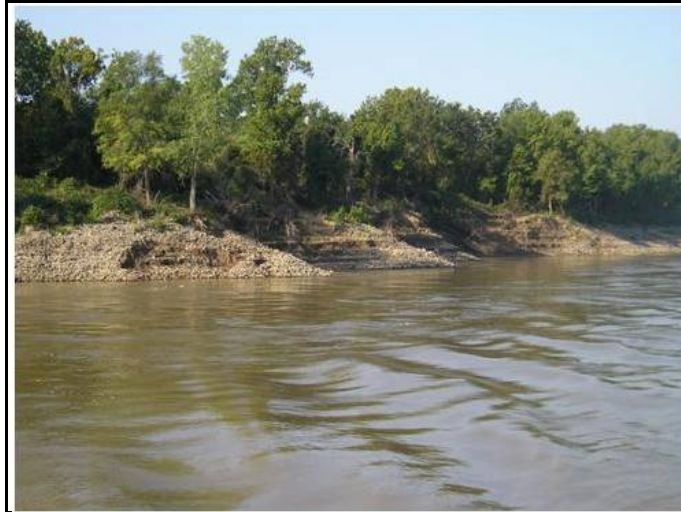
Photograph IV-14. Hard Points

a. Hard Points. Hard points are similar to dikes, but much shorter. In most cases, they have little application for maintaining the low flow channel, but are primarily used to improve channel bank stability in some areas. Typical hard points are shown in photograph IV-14.

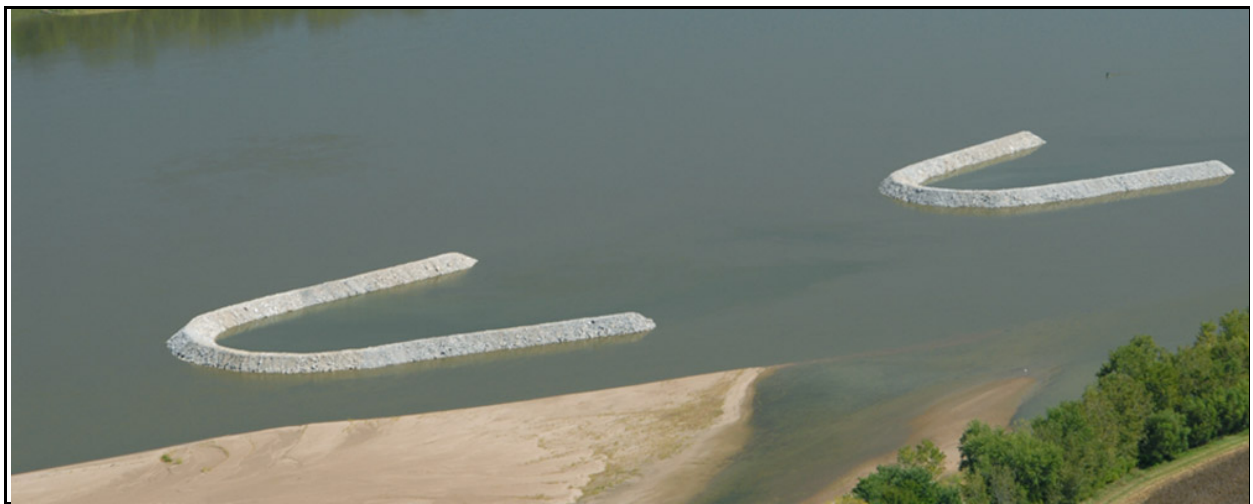
Photograph IV-15. Chevrons

b. Chevrons. Chevrons are rock structures constructed in a “U” configuration with the closed end in the upstream direction located a specified distance from the bank. These structures function similar to dikes to concentrate flow in the channel while providing diversity of flow conditions and channel bottom configurations. Typical chevrons are shown in photograph IV-15.

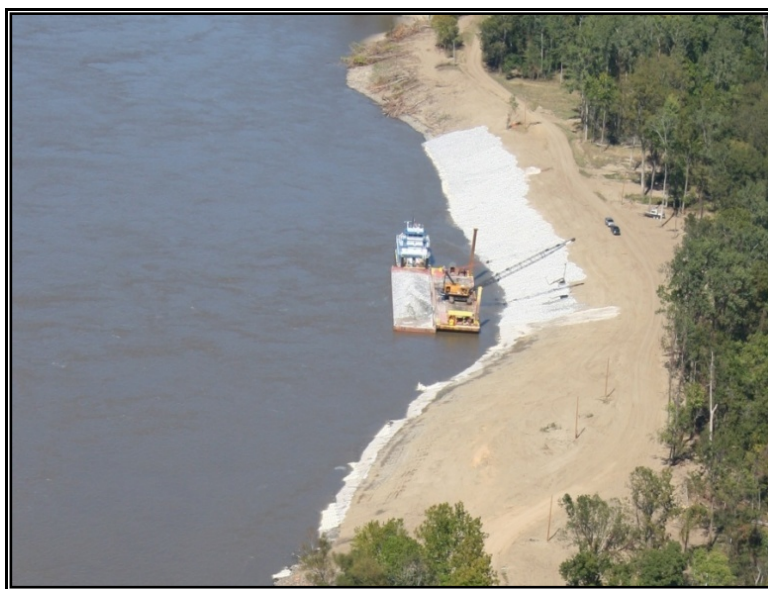
Photograph IV-17 shows an ACM revetment under construction. Note the concrete blocks just above the water surface and the graded bank to accommodate the placement of the upper bank paving.

Photograph IV-17. ACM Revetment Under Construction

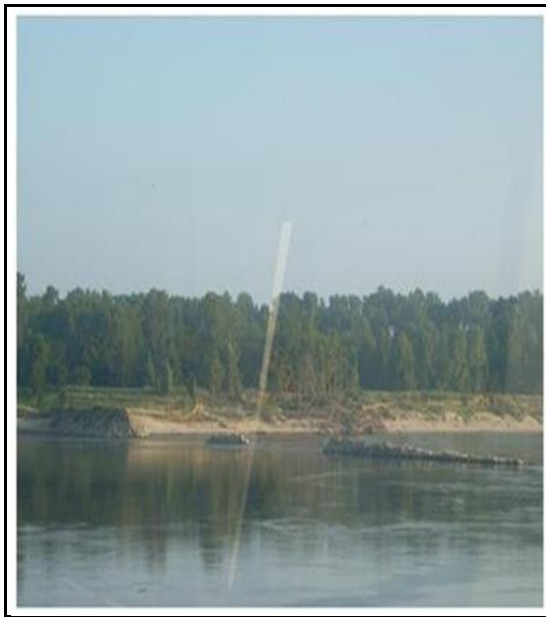
In addition to levee structures and their features, the Channel Improvement community has identified approximately 240 MR&T channel improvement sites that sustained damage to revetment and/or dikes during the 2011 Flood on the Mississippi and Atchafalaya Rivers, 44 of which could have an impact on system performance if not repaired. Some of the most significant include Cache-Cairo, Third District, Chute of Island 8, Merriwether-Cherokee, President's Island, and Walnut Point/Kentucky Bend. A brief discussion of the each of these can be found in Appendix G, *Economics*. Typical damage is shown in photographs V-1 through V-4.

Photograph V-1. Typical Damage to a Dike

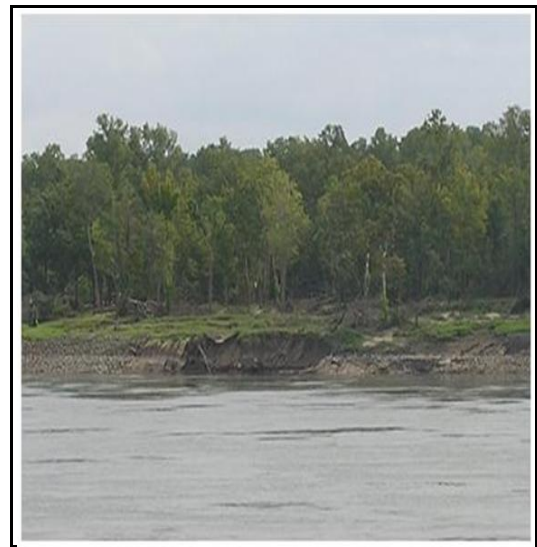
Photograph V-2. Typical Damage to Revetment

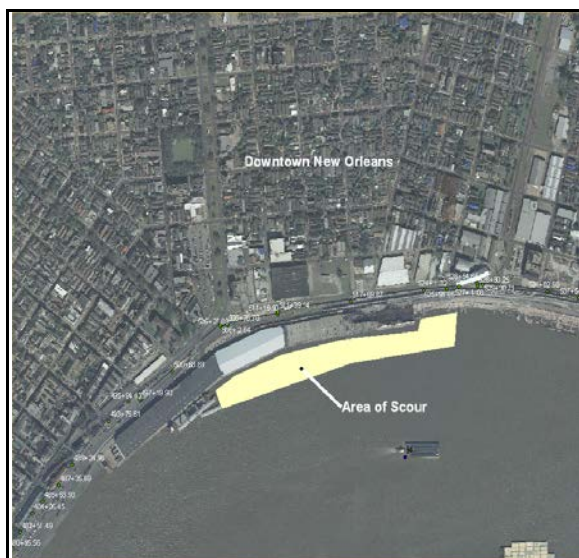
Photograph V-3. Location of Critical Scour

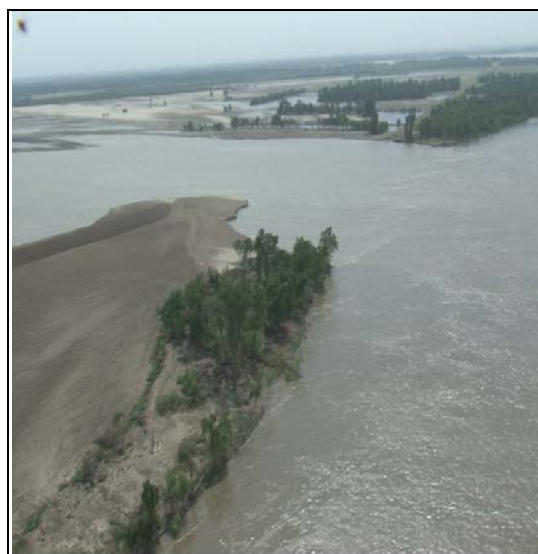
Photograph V-4. Example of Overbank Scour

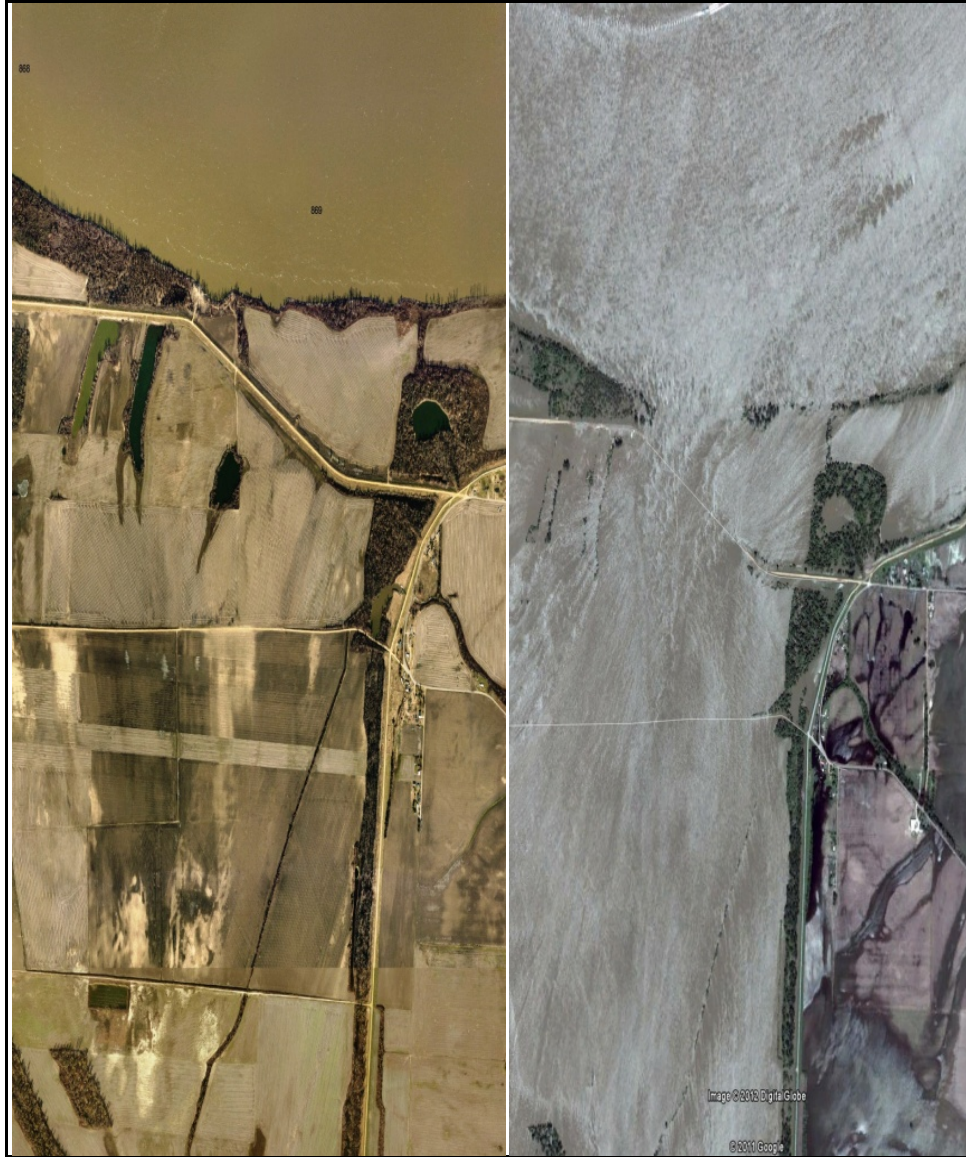
Photograph V-5. Aerial View of Merriwether-Cherokee Revetment Site in Lake County, TN
The photo on the left shows the area before the flood of 2011. Note the narrow band of trees along portions of the Mississippi River bank. The photo on the right is an aerial view of the same revetment site during the flood of 2011. Flow moved across areas with little riparian buffer/tree screen. Improved tree screens may have reduced erosion and flow velocities sufficiently to reduce the damage in the area.

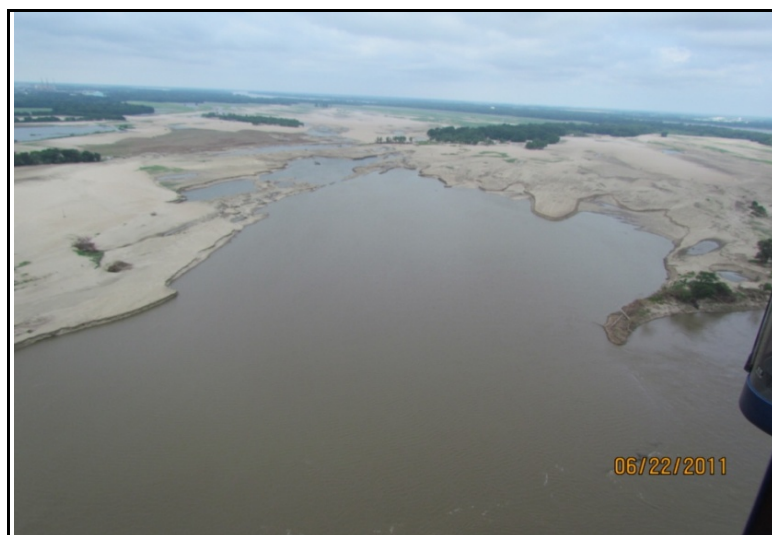
Photograph V-6. Damage Caused by Overbank Flow at Presidents Island

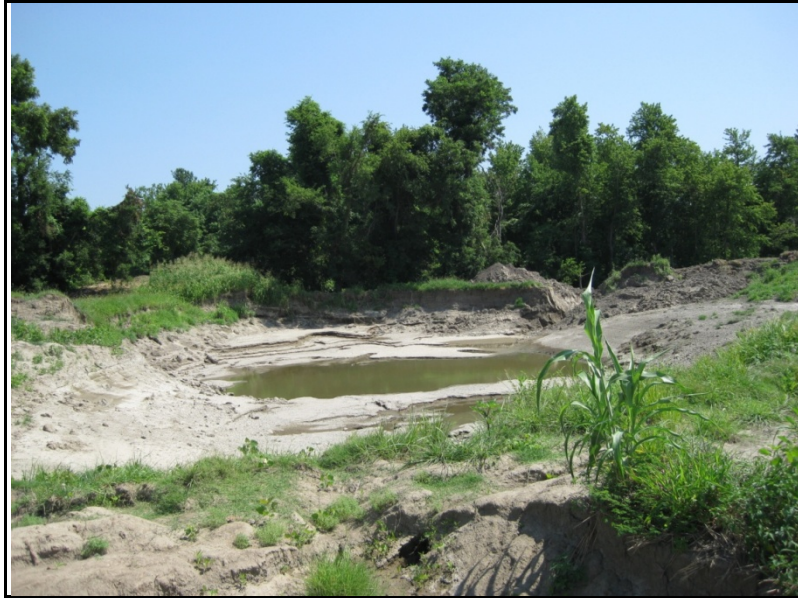
scouring around the north end of Birds Point frontline levee. At this location, scouring damaged a previously undetected, late-Mississippian archeological site (National Register site number is 23MI136) (photograph V-11). The flow entrained and transported prehistoric human skeletal remains and related artifacts (e.g., faunal material, pottery pieces) over a seven-acre area. This inadvertent discovery was identified during the immediate post-flood period (June 2011) during the early stages of the “Operation Make Safe” levee restoration.

Photograph V-11. Large Areas of Soil Scour After Spillway Operation at the BPNM Floodway
In this area, soil erosion led to the exposure of a previously unidentified burial site (23MI136).

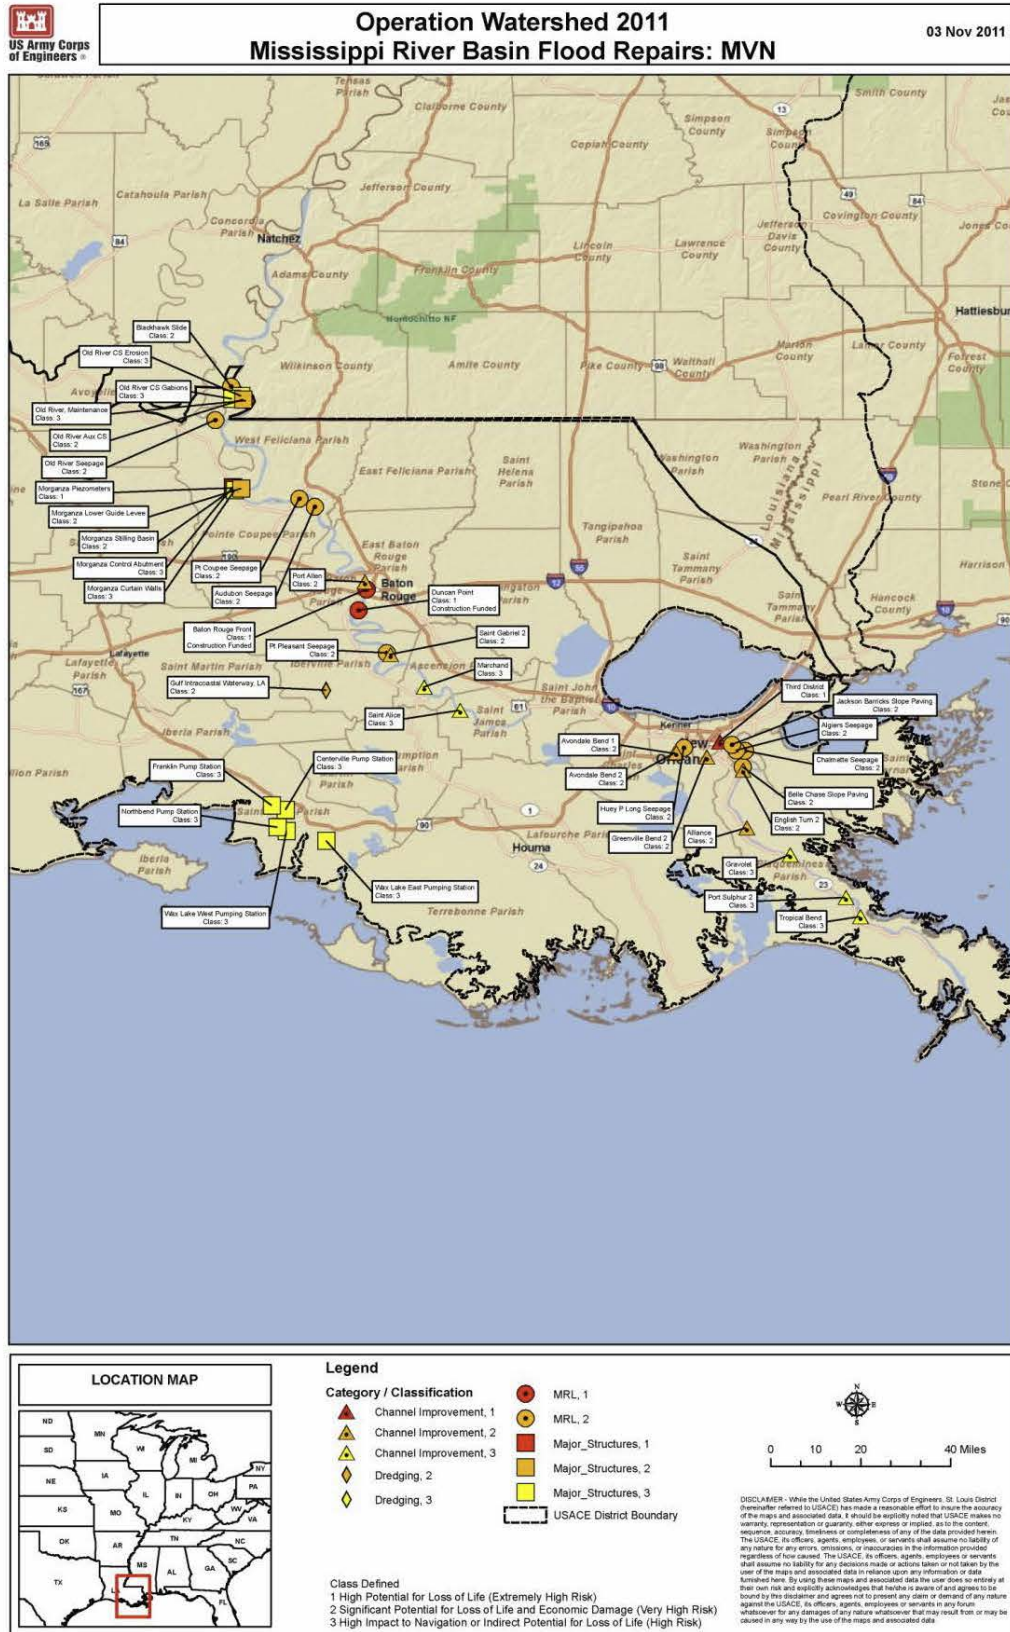
Figure VI-4. Damaged MR&T Components and FRAGO Risk Classification Within MVN

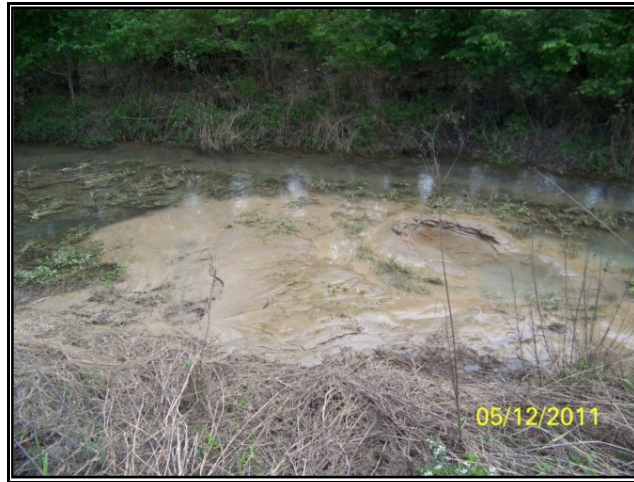
System performance during the 2011 event revealed deficiencies in seepage conditions and levee slope stability. During the 2011 event numerous medium sand boils moving significant amounts of material formed within the relief well collector ditches (photograph VI-4). As a result of the sand boil activity the ditch bank failed in several locations. In addition, a large levee slope stability failure occurred that extended over 100 feet along the levee and had a 3- to 4-foot face.

Photograph VI-4. Sand Boil in Relief Well Ditch

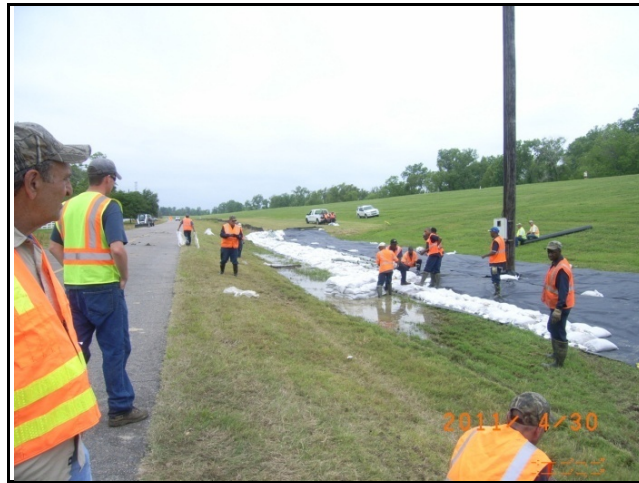
Photograph VI-16. Duncan Point Seepage

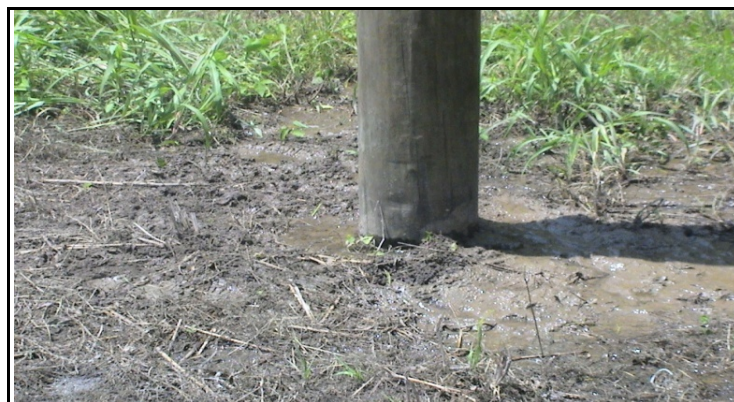
iv. SYSTEM #4415 – Mississippi River Westbank – Above Old River. There was one reported area of sand boils, one old levee slide which occurred prior to this event, and two areas of erosion, which were reported as impacting the future ability of the System to perform if not repaired (photograph VI-20). Considering the observed performance of the levee System and damages that resulted from the event, the overall rating for the post-flood System #4415 is minimally acceptable.

Photograph VI-20. Old River Seepage

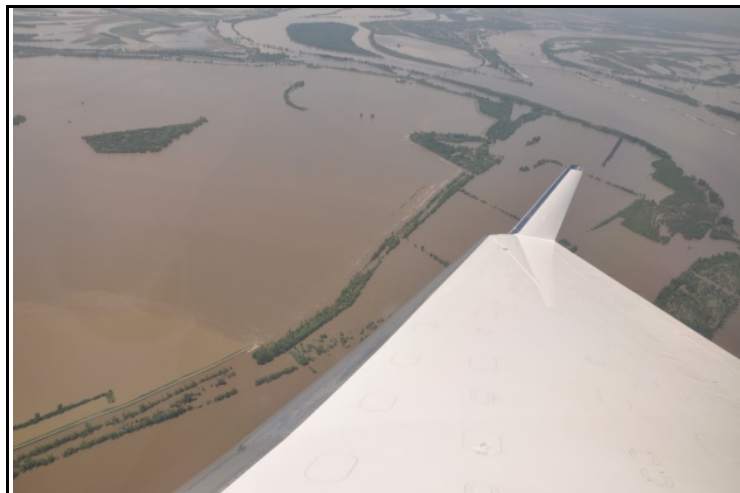
Photograph VI-27. Aerial View of Upper Inflow Crevasse After Activation

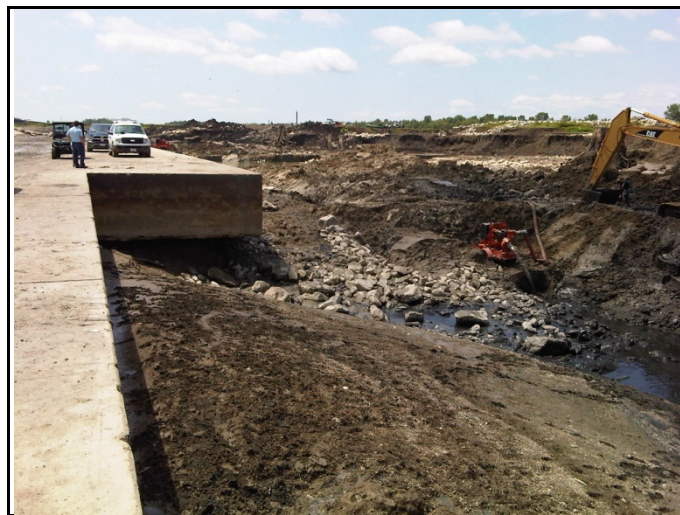
Photograph VI-34. Damage to Morganza Tailbay Showing Scour Hole and Displaced Stone After Dewatering

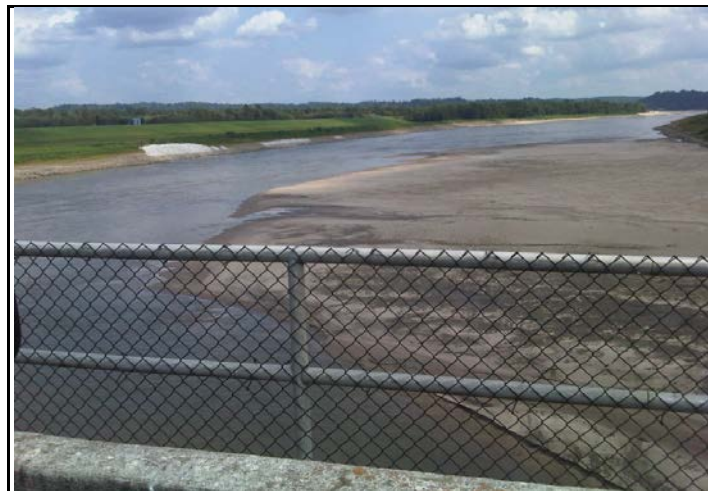
Photograph VI-36. Sediment in the Inflow Channel of the Auxiliary Structure Sandbar Extends Approximately Halfway Across the Channel

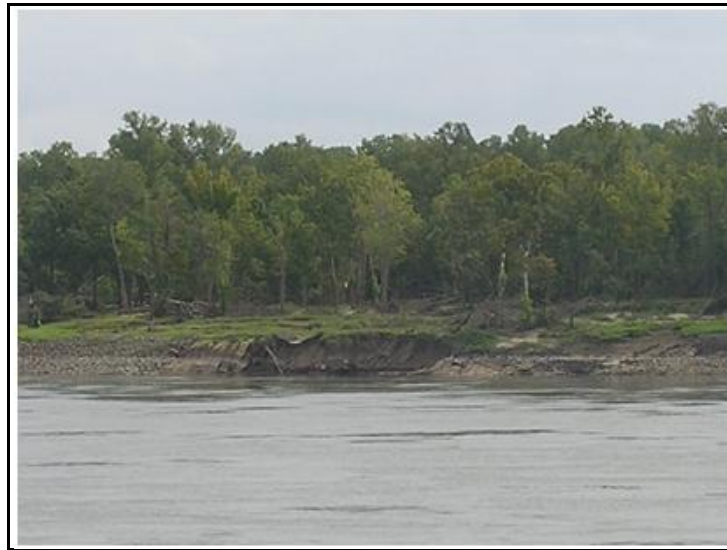
Photograph VI-37. Typical Revetment Damage

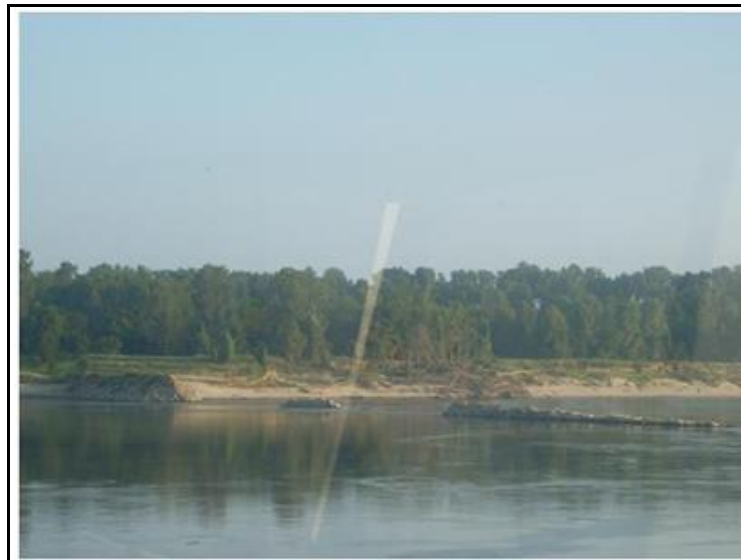
Photograph VI-38. Typical Dike Damage

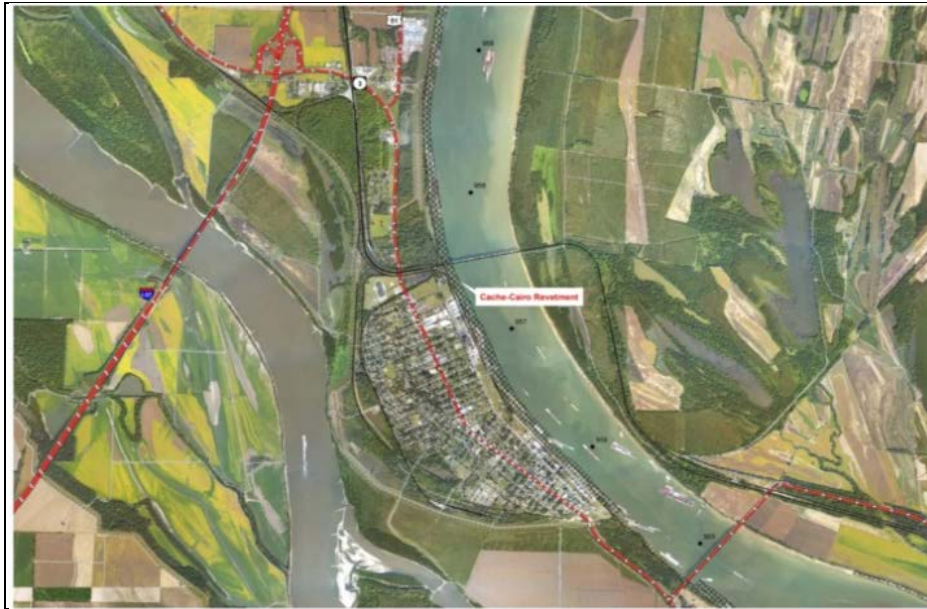
Figure VI-6. Location of Damage to Cache-Cairo Revetment

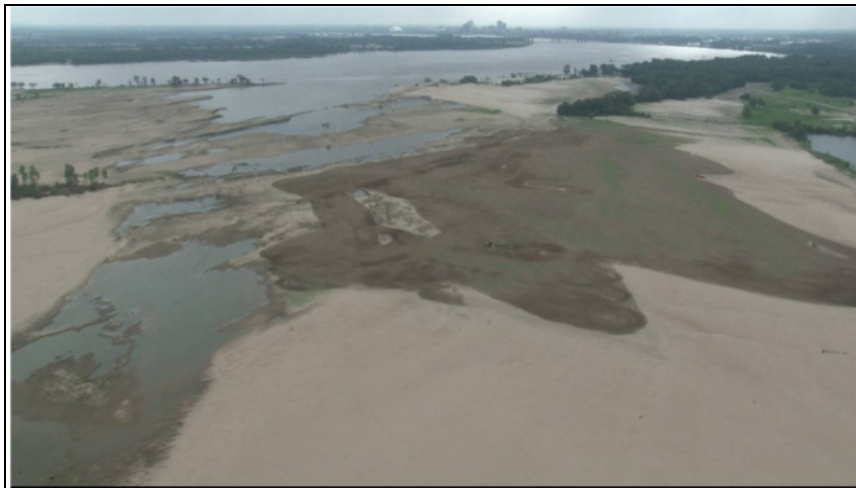
Photograph VI-42. President's Island During 2011 Flood

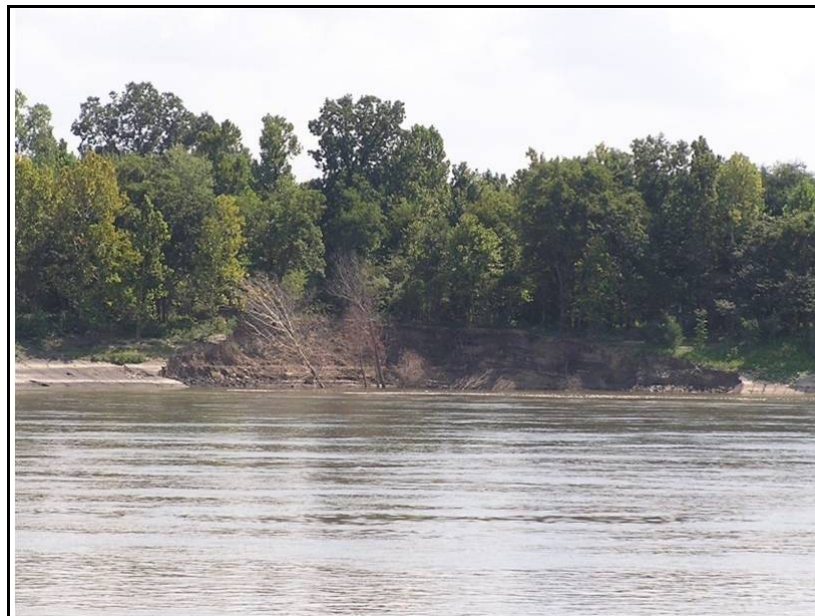
Photograph VI-47 Damage at Walnut Point/Kentucky Bend

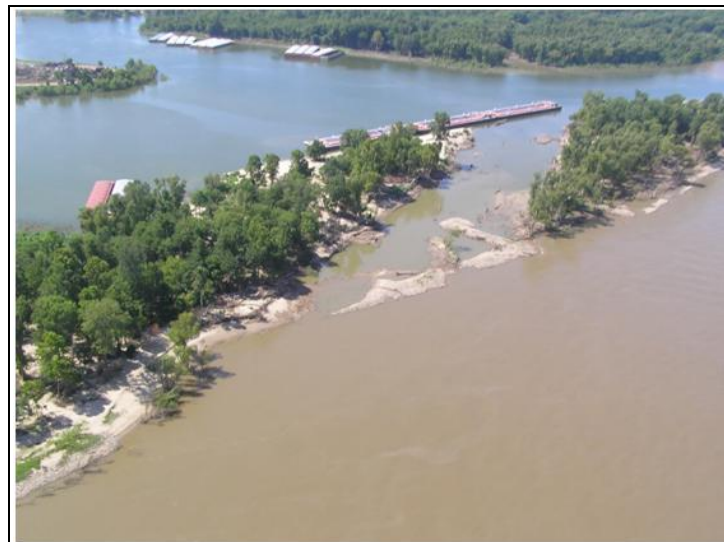
Photograph VI-49. Flood Damage at Leland-LaGrange Revetment Near the Entrance to Greenville Harbor

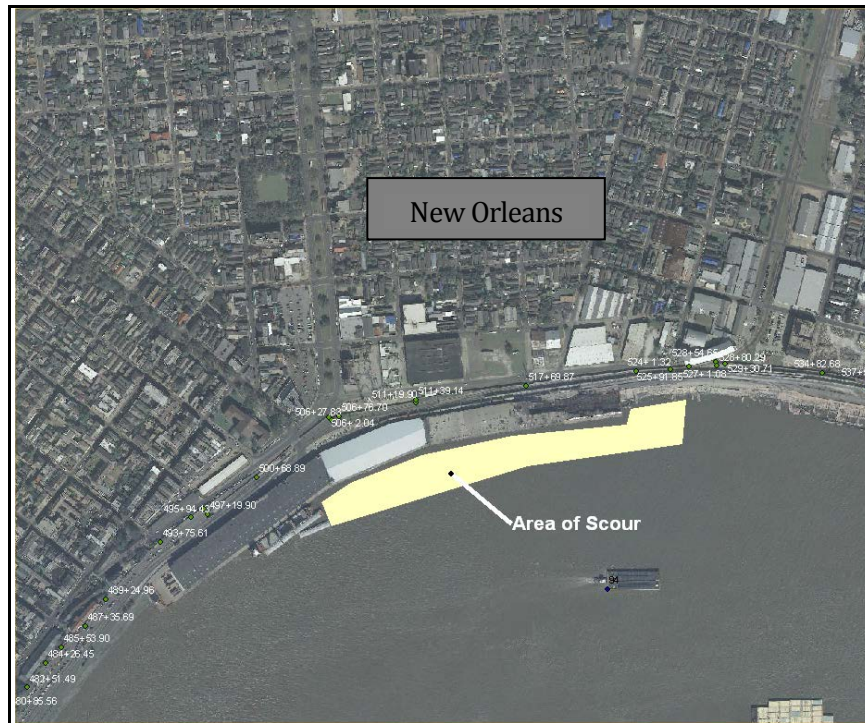
Figure VI-12. Scour Area near Downtown New Orleans

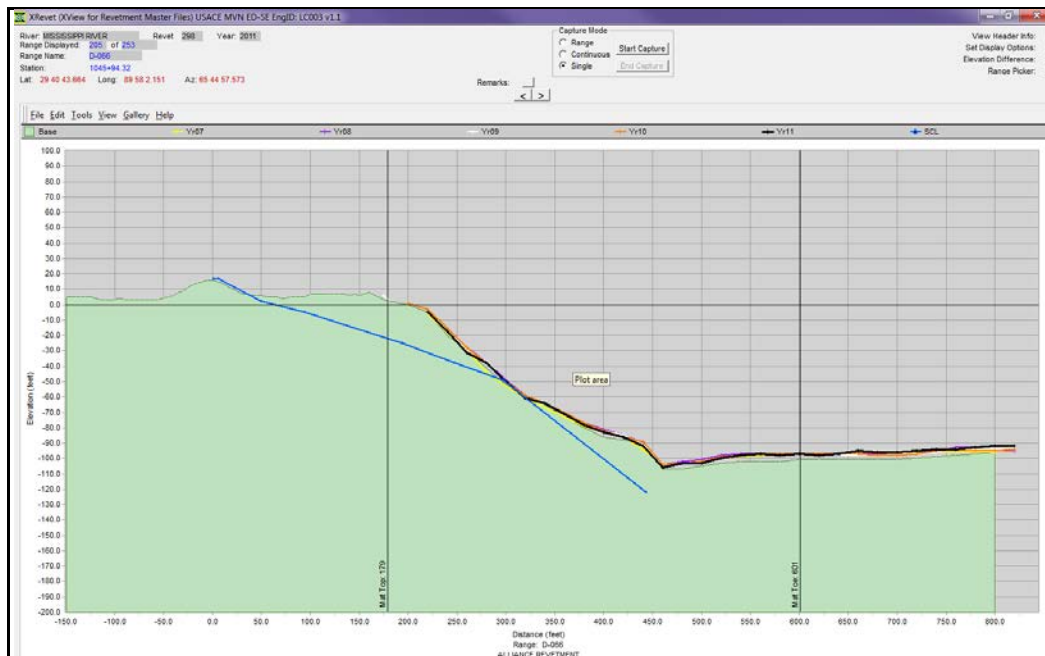
Figure VI-15. Cross Section Showing Stability Control Line Violation

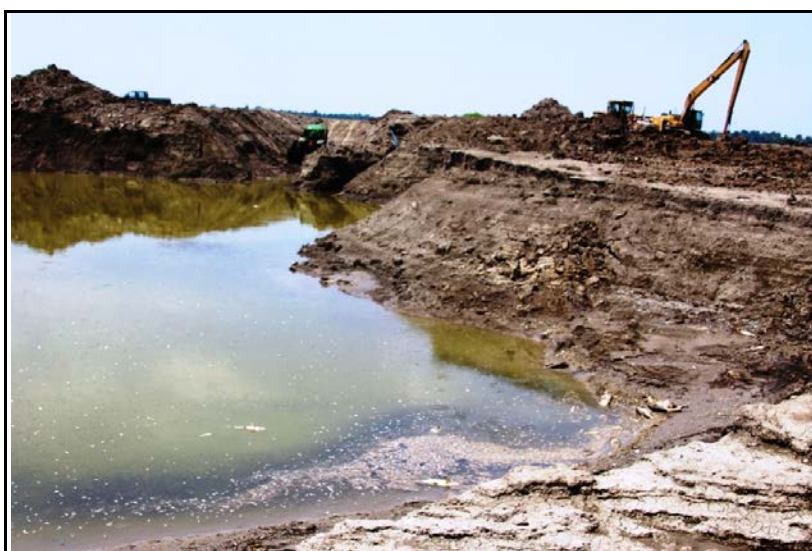
Photograph VI-50. Large Scour Hole Within the BPNM Floodway
As the floodwater receded, the dissolved oxygen level within the remaining water dropped below that required to sustain aquatic life, killing the fish trapped within the scour hole.
